Natural Gas Transmission Line

Portugal

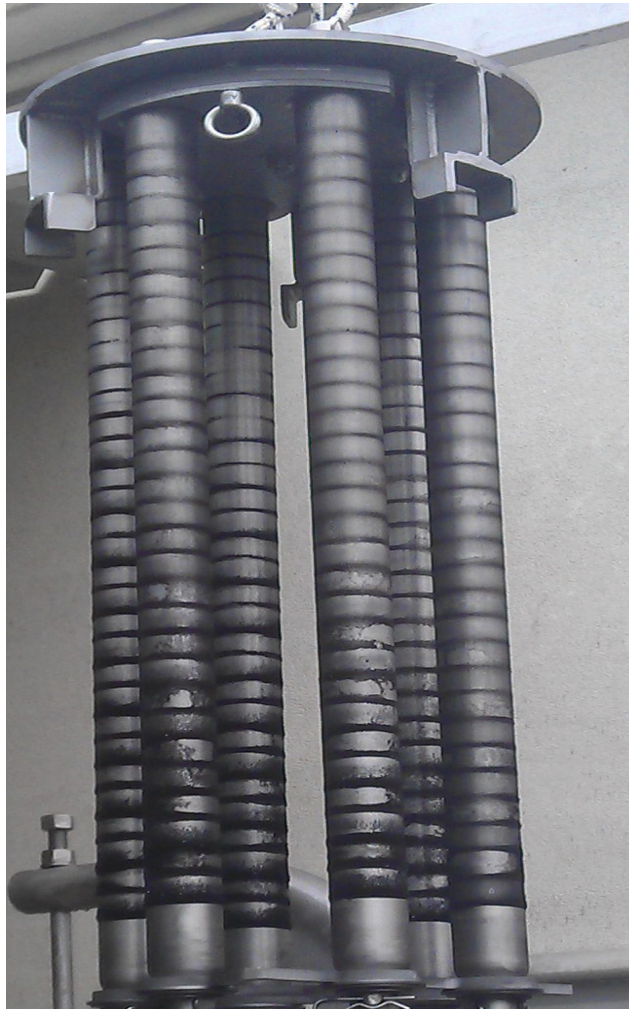
High volumes of black powder contamination in natural gas feed stock were plugging off conventional filtration systems on a 6" OD natural gas transmission line with a flow rate of 2,500 m³/hr.

The photo shows contamination removed after the system's first week of operation. Conventional filters downstream remained clean, helping to identify that 95+% of the black powder was removed by the magnetic separator elements.

Install a magnetic separator system upstream of the depth media filters to remove both ferrous and non-ferrous black powder down to sub-micron levels without impeding flow.
