Black Powder in Natural Gas Systems

December 2020

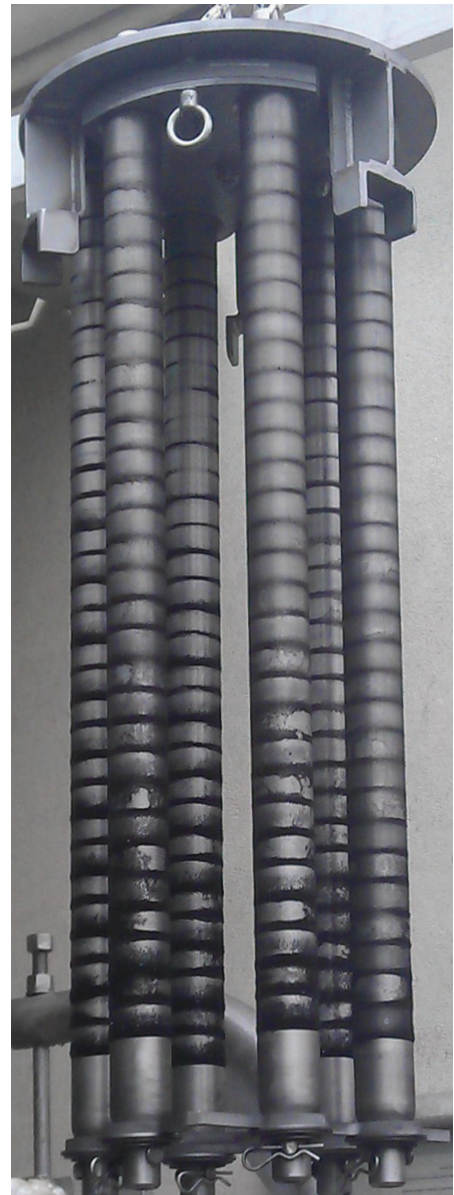
Figure 1. The magnetic array with black powder contamination on it after the array was removed for an initial inspection.

After numerous complaints by the end user, the gas distribution utility commenced evaluating alternatives for eliminating the black powder issue with its customer. The utility ultimately decided that magnetic separation offered the best alternatives for eliminating all of the black powder as well as the costly replacement of single use filters. The Black Powder Solutions magnetic separator system was installed in 2014 and continues to operate with the same high efficiency level. Figure 1 shows the magnetic array with black powder contamination on it after the array was removed for an initial inspection.

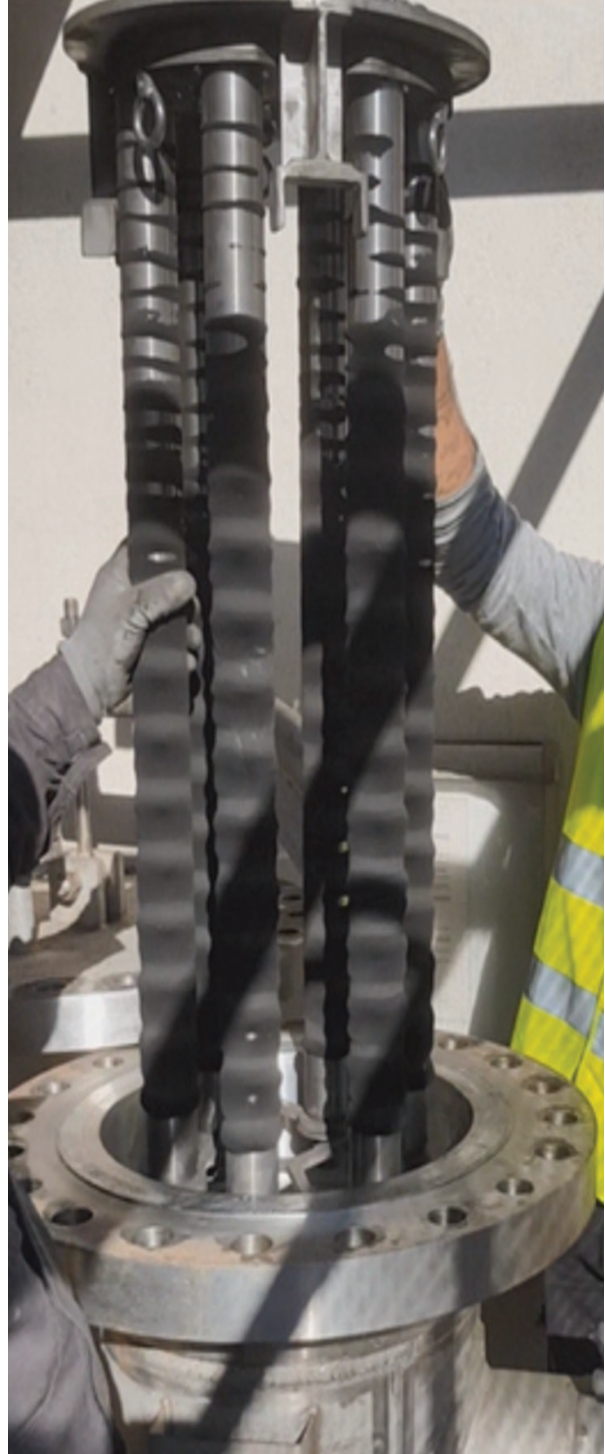
Figure 2. Removing the magnetic array from the magnetic separator for initial cleaning.

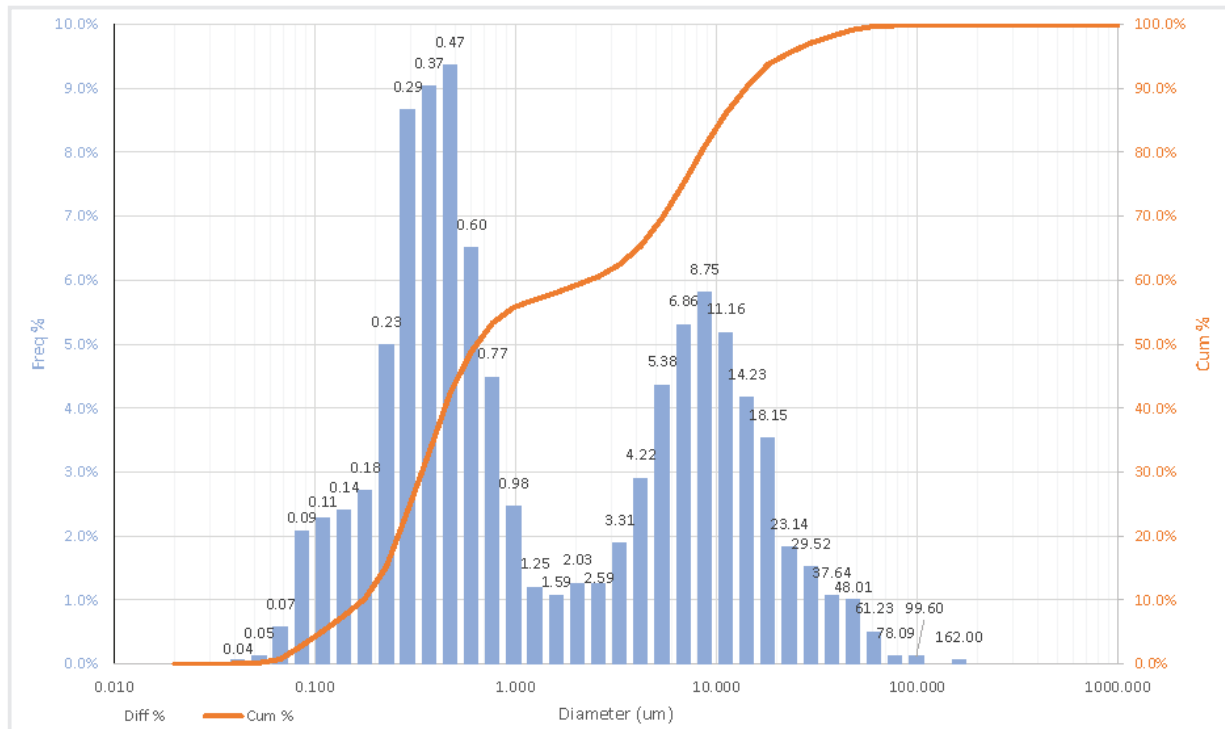
Figure 4. Histogram that illustrates particle size distribution.
