Reclaimed Oil Tank Separator

Proof of Concept Test

Targa Resources - Houston, TX USA, 2016

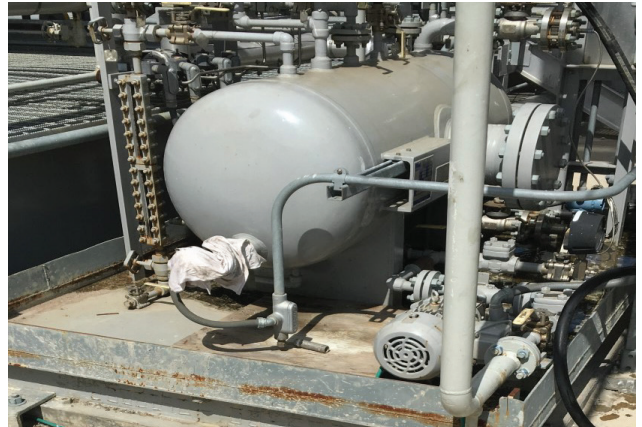
Reclaimed oil tank.

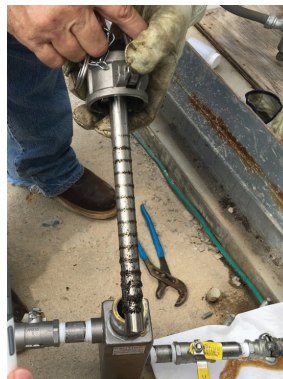
Black Powder contamination captured after 3 minutes.

1. Install the BPS Magnetic Separator System in a drain line in the discharge.
2. Route the hose to a vent in the destination tank.
3. Record results after 3 minutes, 10 minutes and 1 hour.

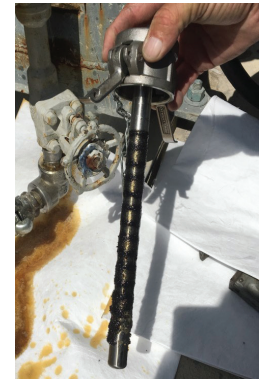
Black Powder contamination captured after 10 minutes.

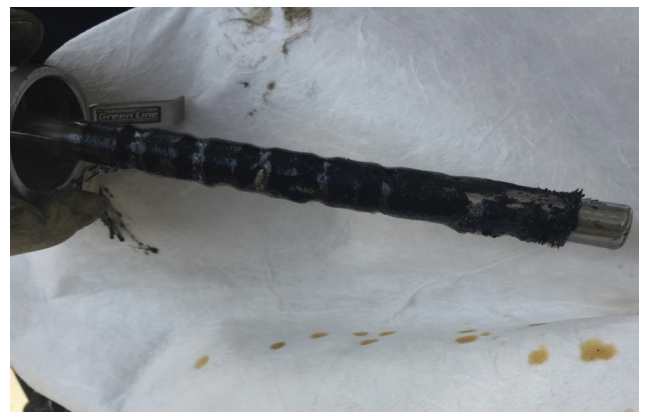
Black Powder contamination captured after 1 hour.
